# Building Maintenance Snapshot Feb 2026

## A Pre-Election Review for Residents

This document highlights **ongoing, unresolved maintenance issues** in our building to help residents make informed decisions in the upcoming HOA elections.

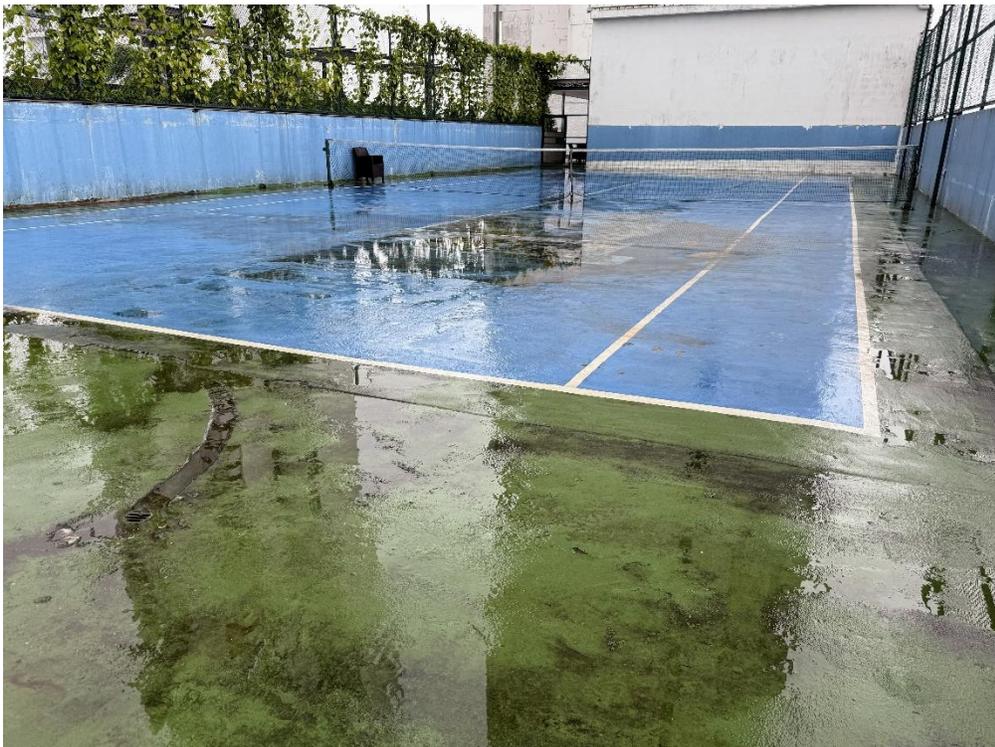
#### a) Tennis Court unusable since more than 3 years

- Intended use: Tennis and padel ball.
- Current reality: unusable due to dangerous surface defects.
- Duration: Multiple years
- Impact: Residents pay for an amenity that is effectively unavailable

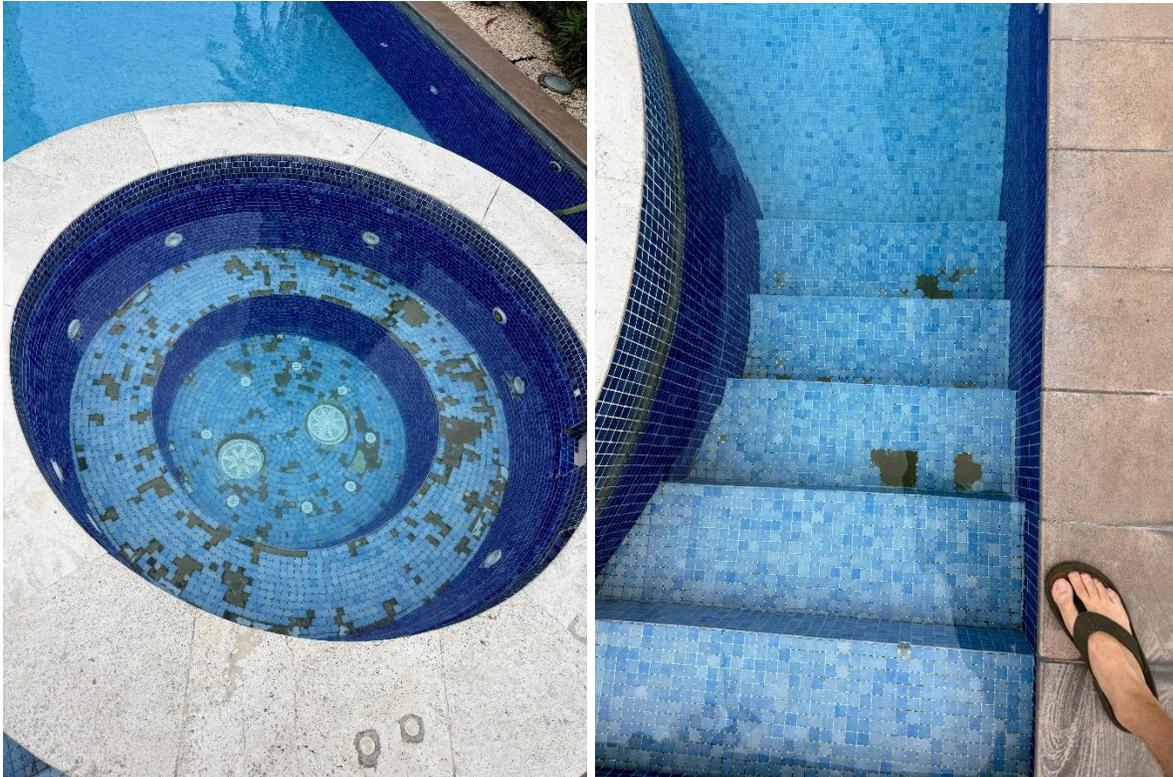
### **b) Jacuzzi Pool continues losing it's tiles**

- Current reality: we continue to loose tiles at a rapid rate
- Duration: 2-3 years
- Impact: Residents pay for an amenity that looks unmaintained and feels terrible

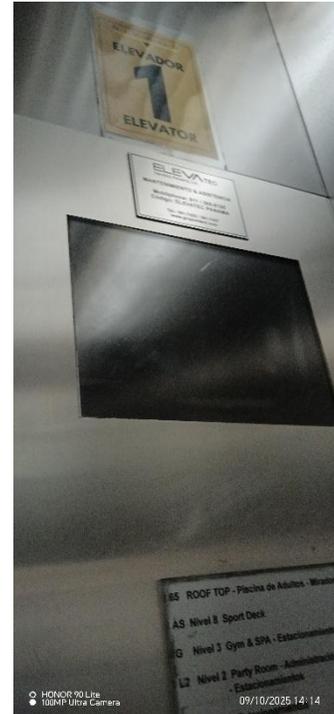
### Elevator #1 – Non-Functional Display

- Issue: Monitor not working so you don't know which floor was selected.
- Duration: Several months
- Impact:
  - Reduced usability
  - Accessibility concerns
  - Negative daily experience for residents

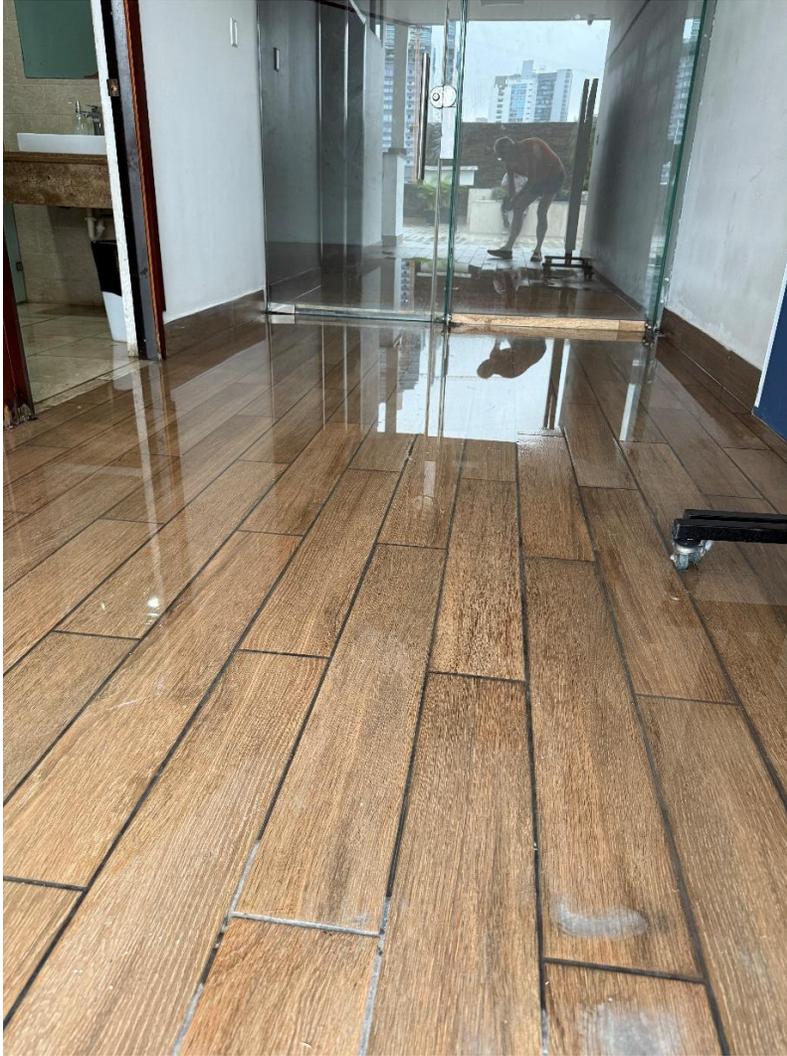
Water not being able to drain after heavy rains. It pools in front of the entrance to the racket ball court and sometimes even enters the bathroom.

Drill drain hole through floor into level 7 garage ceiling and connect new drain pipe with existing drain plumbing.

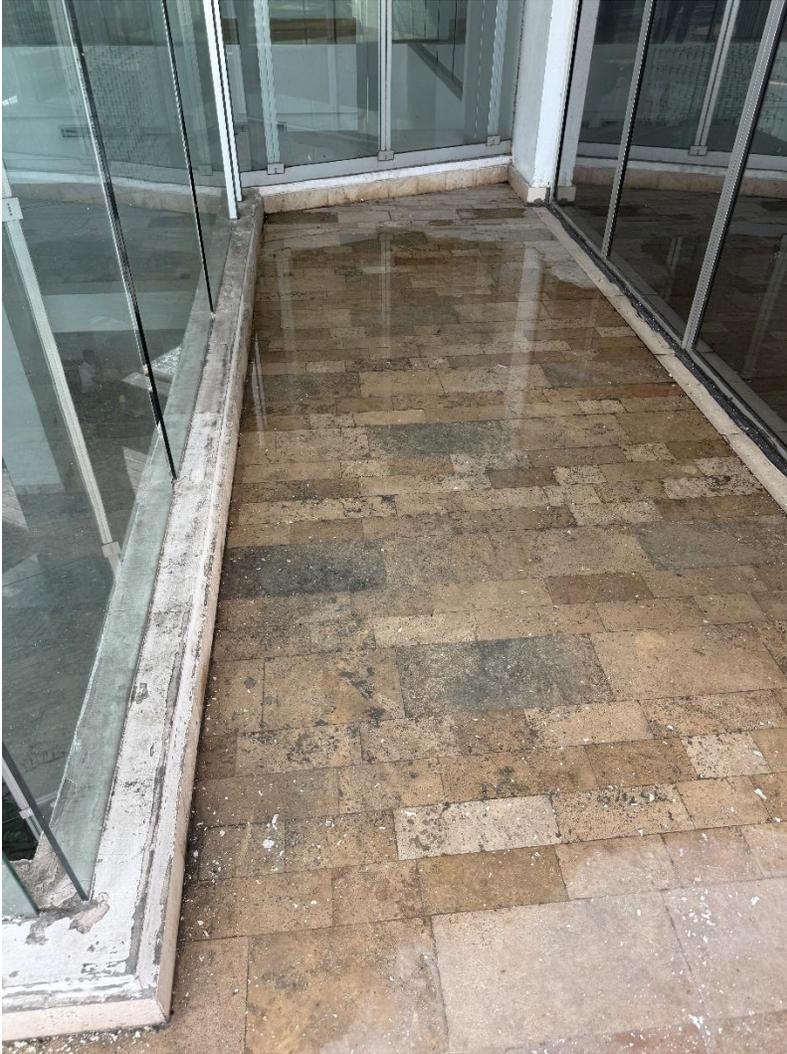
Water pooling after heavy rains on L2 balcony causing filtration issues in lobby ceiling and walls.

Install proper drain or re-level tiles with proper slope forward to the drains available.

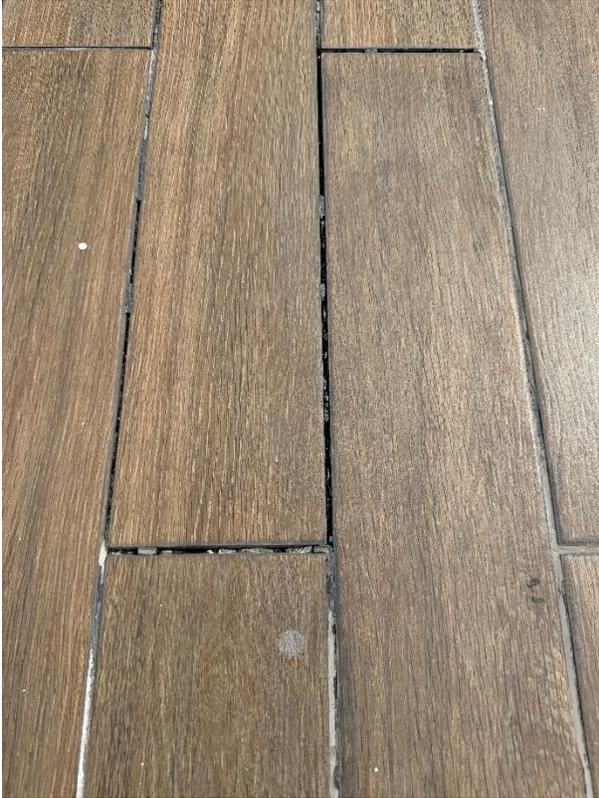
Grout on floor tiling on level 8 is failing and missing in many places. Water enters now the ceiling and ultimately ends up in the garage level 7 ceiling making many parking spots unusable.

The same is starting to happen on level 66 as well.

Remove loose grout and pressure wash the cracks. Then reseal with new grout.

Ultimately we should remove all tiling and re-level the entire floor to ensure proper drainage to existing drains. Then proper waterproofing of the concrete has to be applied before new tiles are installed. That will prevent water from entering the concrete floors/ceilings when grout is failing later.

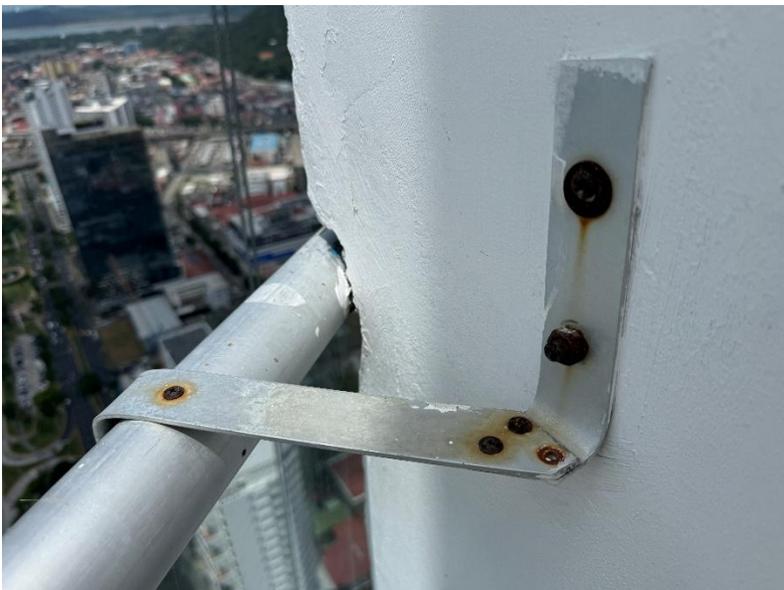
There are at least 6-10 more such brackets that need to be fixed.

Replace existing hardware with proper new hardware.

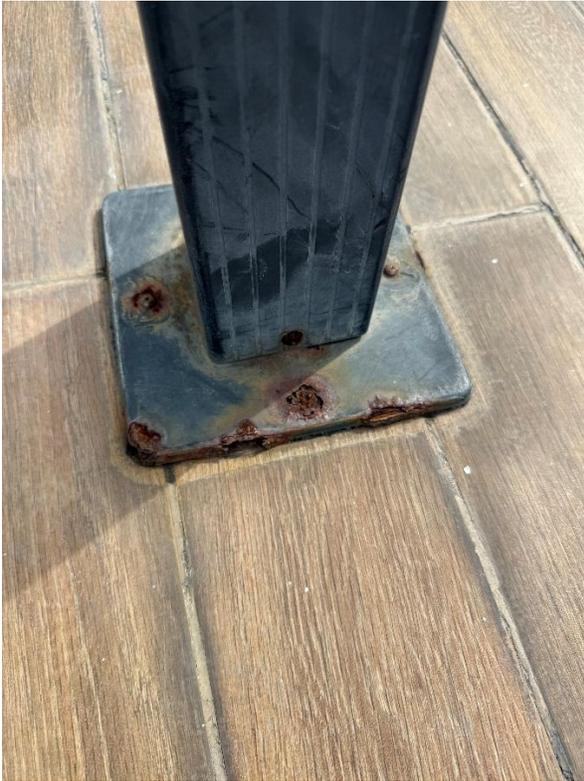
Sun shade posts on level 8 are corroded and no longer safe. If someone leans against them they might fall over.

Replace with a new shading solution.
